AMCP 385-99

JANUARY 1971

**HEADQUARTERS
UNITED STATES ARMY MATERIEL COMMAND
WASHINGTON, D.C. 20315**

AMC PAMPHLET Number 385-99

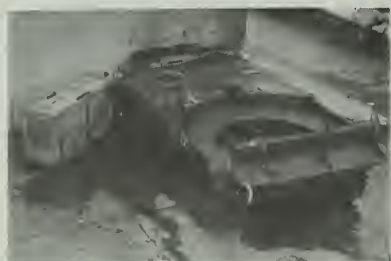
Position of M110 combat vehicle with respect to both welding units.

One of the welding units was pushed through the sidewall of the building, and the resultant impact caused the welding unit's gasoline tank to explode. Although the flames enveloped the driver, he was able to disembark from the vehicle unassisted and help toward extinguishment of the blaze.

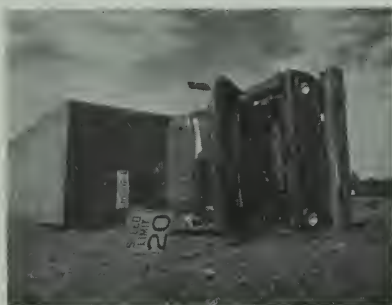
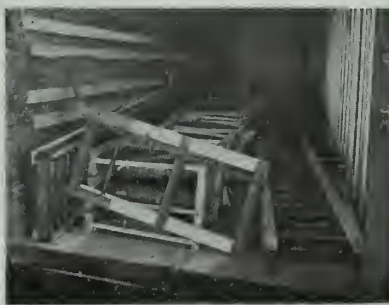
Overtuned vehicle, front view. Cargo, 175mm projectiles.

The tractor received damage to the door, mirror, fender, grille and front spring, all on the right side of the vehicle. Also, the trailer was damaged on its right side. As a result of packaging configuration, the cargo incurred no damage. Total damage costs to both tractor and trailer were estimated at \$2,400.00. The driver was not injured.

Investigation of the accident indicated that excessive speed was the primary cause of the accident. To preclude the occurrence of similar accidents, the installation has taken the following actions:

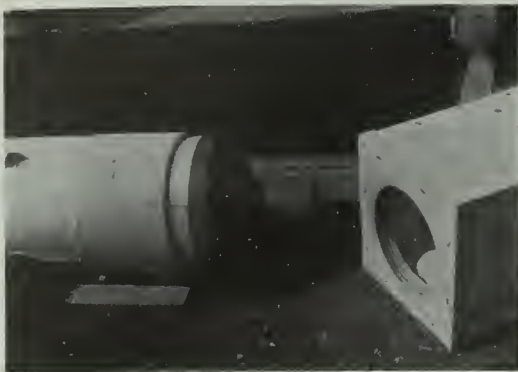
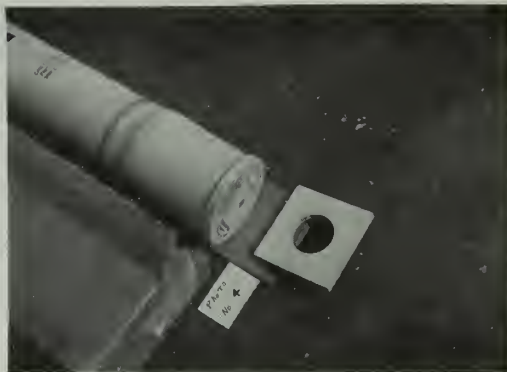
The probable cause of the fire was damage to or heating of a cartridge within the container. Photo 3 shows a round after vibration. Note the wear mark on the slug as a result of motion with the wooden block. Photo 4 shows evidence of slug motion on the fiber spacer. An intensive investigation is continuing to assure that the tests were properly conducted and that no external factor generated the fire.

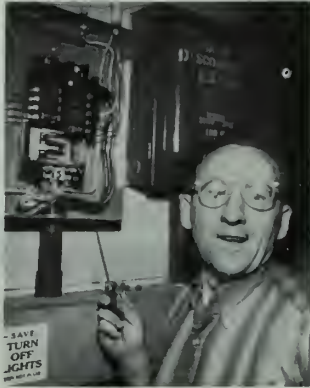
Burchfield, an electrician, was repairing a control panel when a bolt slipped and struck an energized circuit. The resultant flash spewed hot metallic particles onto his glasses. Photo 1 shows the immediate work-site and the lens damage caused by the metal flyings.

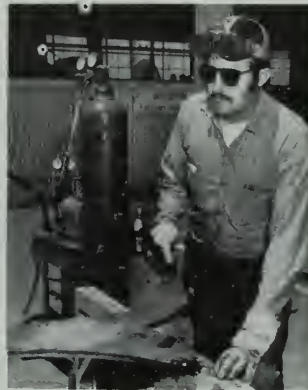
Quinton, a welder was fabricating an engine mounting bracket at the time of the accident. Having completed his cutting operation, he removed his safety goggles, but continued to wear his safety glasses. While chipping the hot slug, a large piece struck his glasses. The operation being performed and the resultant right lens damage is shown in Photo 2.
